DAMAGE TO TREES AND REGENERATION LAYER RESULTING FROM TIMBER HARVESTING WITH THE USE OF EQUIPMENT AGGREGATED WITH FARM TRACTORS IN THINNED MOUNTAIN STANDS

Arkadiusz Stańczykiewicz

University of Agriculture in Krakow – Faculty of Forestry
Department of Forest and Wood Utilization
Al. 29 Listopada 46; 31-425 Kraków; Poland
e-mail: rlstancz@cyf-kr.edu.pl

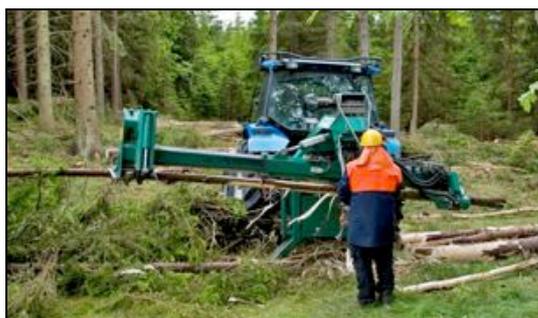
Figure 1. Tractorprocessor NIAB 5-15
(www.forsmw.com)

In case of the surfaces on which the processor was working, the role of the chain saw operator was reduced to cutting and felling trees. Debarking and cross-cutting was performed by a processor located on the skidding routes (Fig. 1). The obtained basic material in the form of the middle-sized timber logs, was situated in irregular piles, directly by the routes from which it was then skid by means of self-loading trailers. Therefore, the described technology could be qualified within the framework of Cut-To-Length method ($CTL_{TractorProcessor}$) with two-stage skidding.

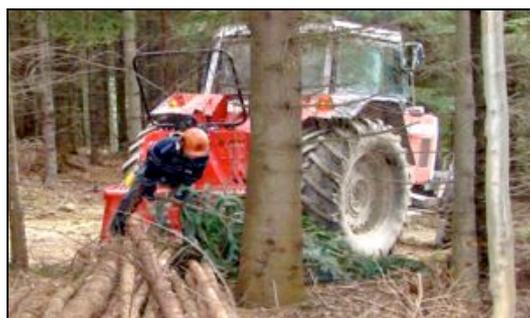
Figure 2. Cable winch KRPAN 8EH
(phot. A. Stanczykiewicz)

In case of technologies with cable winches the logger's task, apart from felling a tree, was also debranching and cross-cutting the material. After cutting off the tree top, the whole-length trees were skid to the skidding route by cable hauling, after which they were transported to upper landing by skidding after leaning tree-stumps against the winch plate (Fig. 2). Such procedure can be qualified as Tree-Length-System ($TLS_{CableWinch}$) (Pulkki, 2004). Manipulation plot areas were set up in such a way that the maximum logging distance of the skidding in the first stage would not exceed 50 m. During the logging, forest workers did not use any means, such as self-clenching, openwork skidding tongs or cross tree

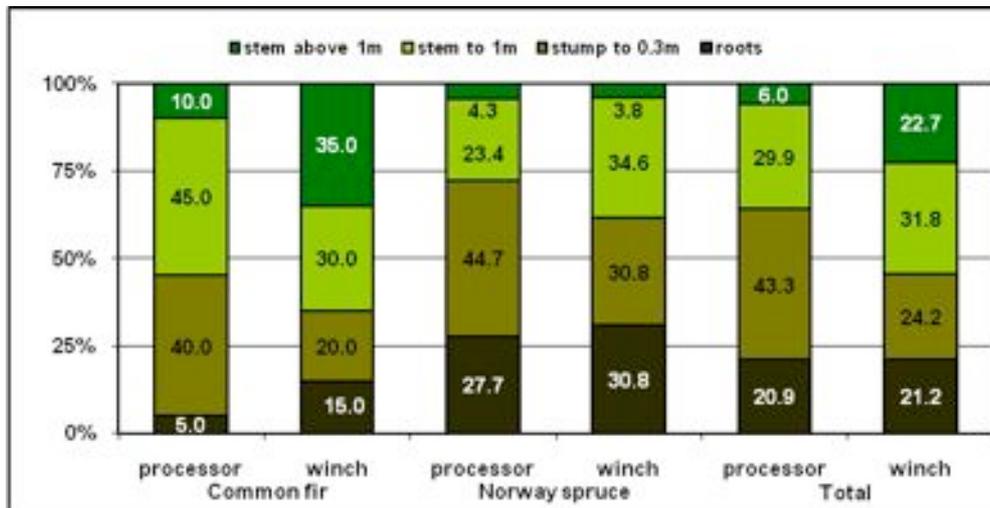
Figure 3. Distribution of injuries on trees

The analysis of injuries' distribution on the stems of all trees damaged as a result of applying both technologies showed that about half of them (45.4–64.2%) occurred on roots and the root neck (Fig. 3). The obtained results confirm the earlier research. As shown in the diagram presented by Butora and Schwager (1989) concerning the distribution of injuries on the stem, almost 55% of injuries occur on the roots and the root neck up to 0.3 m. The greater share of the injuries in the lower spruce stands results from the morphological construction of the spruce with a large number of roots growing shallow in the soil and protruding from it. Analogical outcomes were achieved in the research by Sowa and Stańczykiewicz (2007), in which over 2/3 of the lowest injuries (68.4–75.9%) were noted in the spruce stands, both as a result of using horse skidding technology and the light Multi FKS cable winch powered by the chainsaw engine. In the quoted research the average areas of injuries oscillated at the level from 62 cm² with the use of the light cable winch to 68 cm² with the use of horses, and they were located at the height from 0.26 m to 0.40 m.

4. The study outcomes point to the fact that about half of all injuries made on trees which remain on stand was made on the roots and the root neck up to 0.3 m, and most injuries were located up to the height of 1 m, that is in the higher risk zone of the subsequent depreciation of the most precious, tree-stump timber, especially in the spruce stand.
