SYNTHETIC FIBRE ROPES FOR FORESTRY USE - CRITERIA FOR THE REPLACEMENT OF FIBRE ROPES

Nikolaus Nemestóthy

Austrian Federal Research Centre for Forests, Natural Hazards and Landscape (BFW)
Johann-Orth-Allee 16
4810 Gmunden, Austria
e-mail: nikolaus.nemestothy@bfw.gv.at

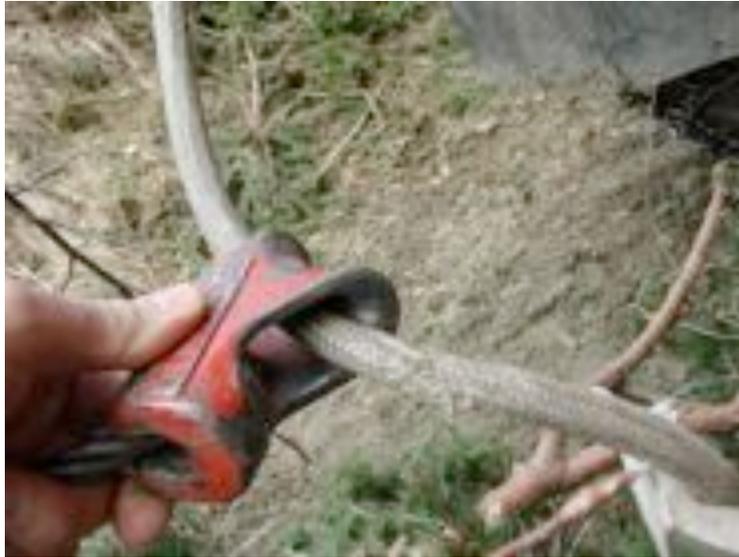
In the gliding area of the chokers the rope is heavily abraded. By improvements in the working method and innovative new developments of gliders the corresponding wear has already been significantly reduced.

Figure 1. Abraded area on a coated synthetic rope

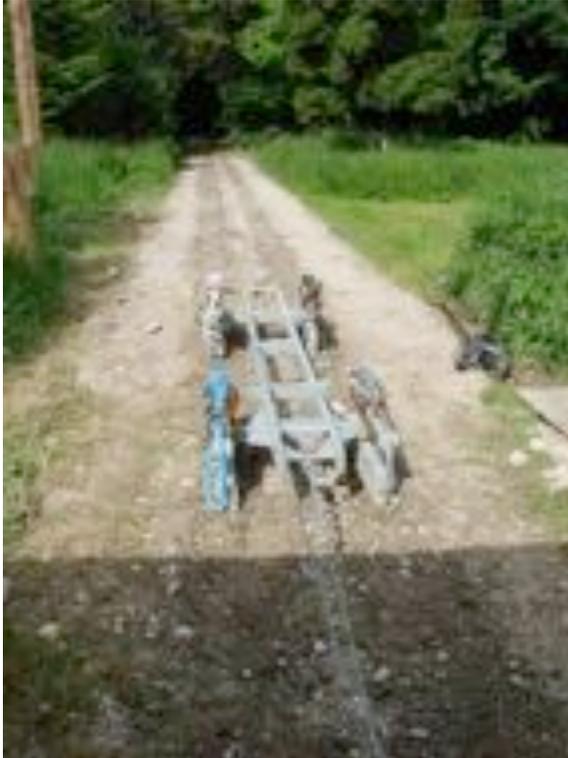
The test pulls were on an even, but abrasive surfaced 35 m track, closely duplicating extreme conditions in logging to simulate the expected fast wear of the rope samples. The necessary roughness was insured through application of limestone gravel (grain size 0/32) mixed with about 25 % humus. In order to simulate fixed

obstacles in extraction and to prevent the track from gradual depression, seven concrete sleepers were built diagonally into the track at a distance of about 3.5 m apart. The track was always levelled before starting a new test series. The test ropes were fastened with approx. 250 kg traction on wooden skids attached to a specially crafted carriage, drawn by a self propelled winch.

Figure 2. The testing track and the special carriage with 4 wooden skids

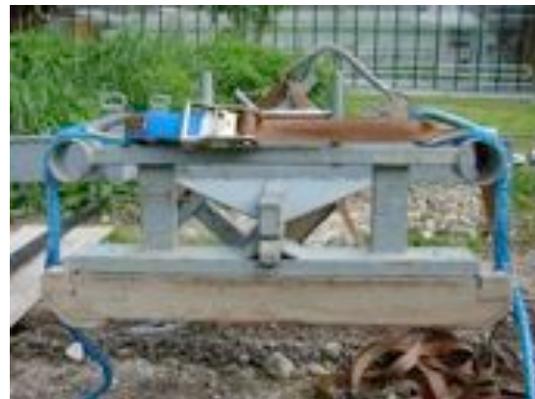
Figure 3. The test rope is fastened on the skid

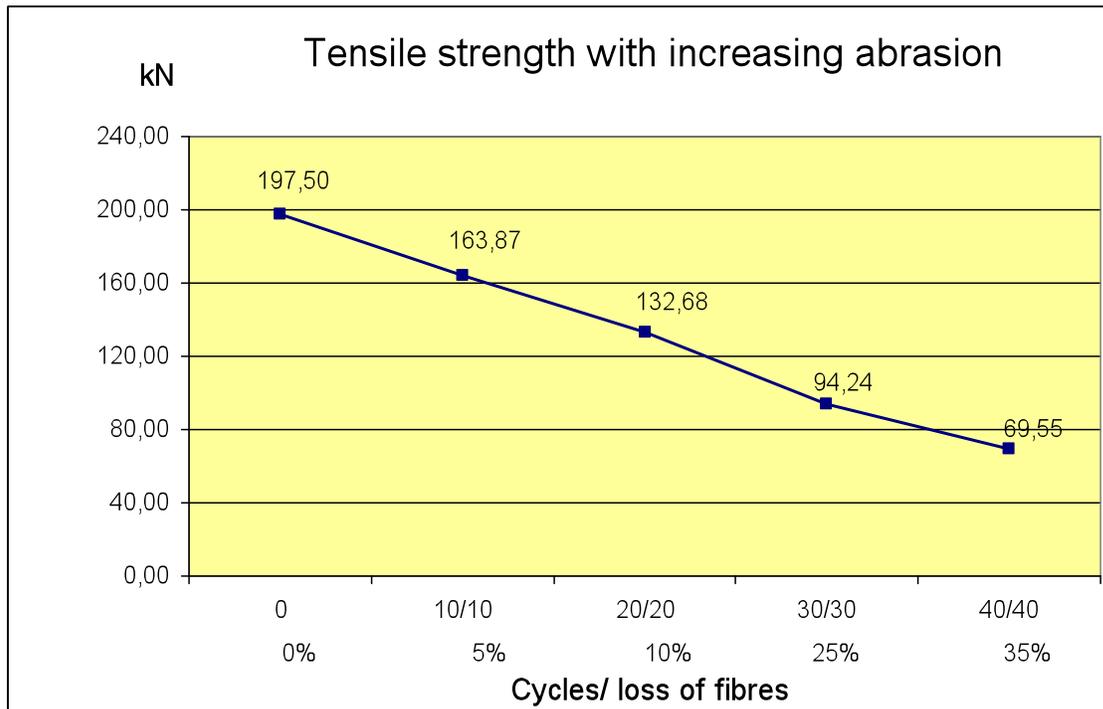
Up to the deadline for this report, 5 ropes were tested from different product lines for use with 8 tonne winches with according minimum breaking forces of more than a 160 kN, but there has been only one rope, the reference rope, tested till now at all frequencies (0, 10, 20, 30.40 trips).

Figure 4. Results from the reference test rope

It seems, that the determination could only be successful by precise evaluation of the loss of fibres in each individual yarn, as done for estimating the loss of fibres for the reference rope (Figure 4). The increasing data base will show the trueness of this method to constitute a executable way to check the intact rope

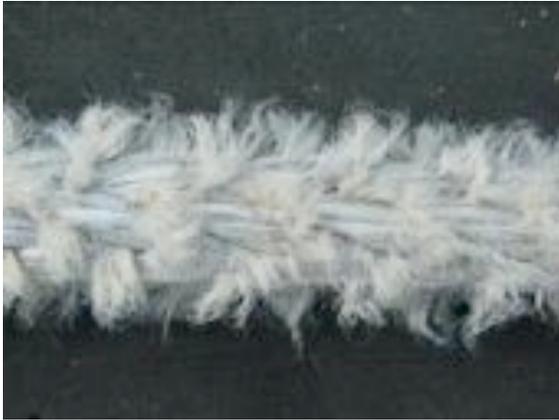
Figures 5. The reference rope after 10 trips

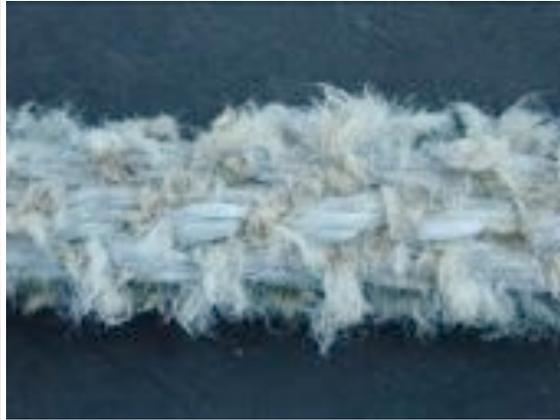
Figure 6. The reference rope after 20 trips

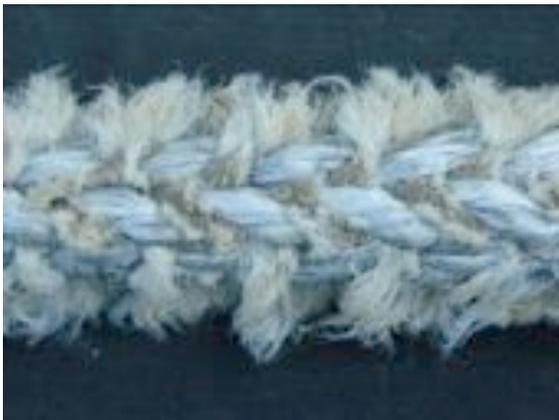
Figures 7. The reference rope after 30 trips

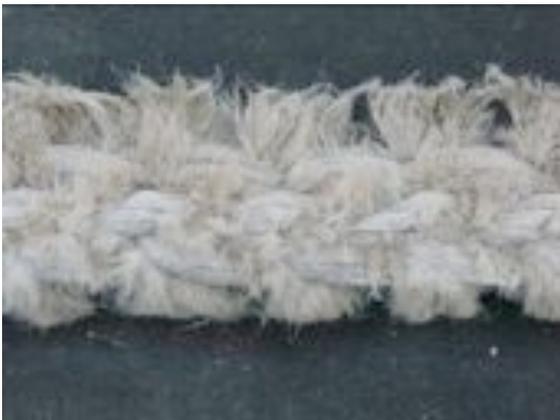
Figure 8. The reference rope after 40 trips

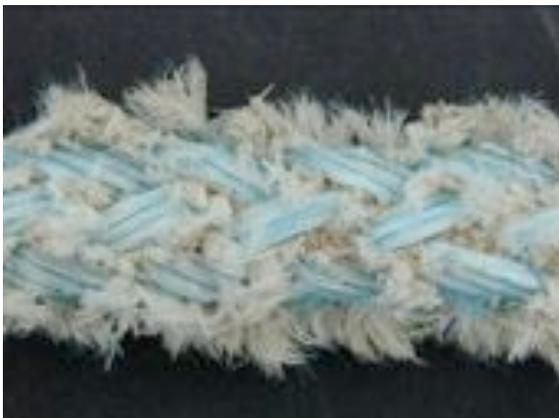
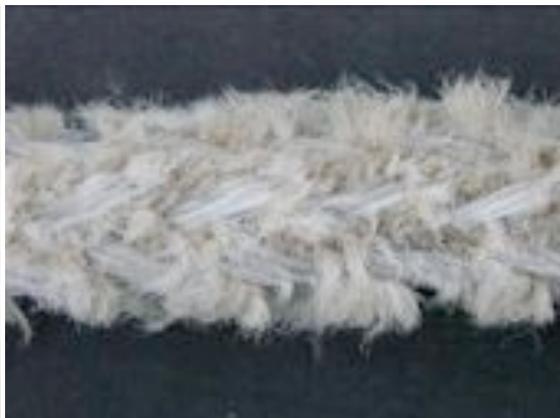
The results of the tensile strength check after 40 trips with not more than 20% to 35% loss of individual fibres were that the ropes had lost 55 % to almost 73% of their original minimal breaking force.

Figures 9. The surface of two test ropes after 40 trips

This was very surprising, because the superficial check of the worn ropes showed only minor damage comparable to the surface of similar ropes after a few weeks of usage, presuming a high tensile strength.

Figure 11. Harvester hanging in a steep slope on a rope in condition similar to the test ropes on figure 9

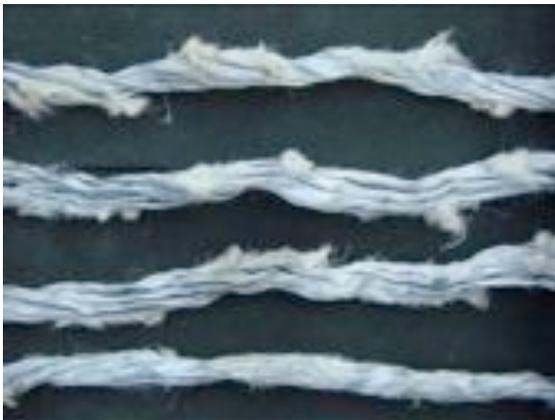
Figure 12. Strands from 4 differently worn ropes

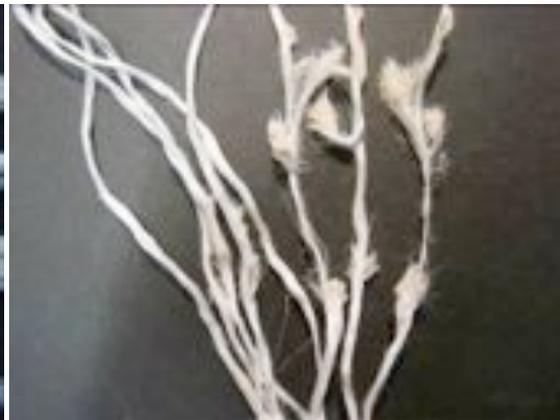
Figure 13. The loss of fibres could be estimated at the individual yarns of the strand
