Fly ash for forest road rehabilitation

Tomi Kaakkurivaara
tomi.kaakkurivaara@gmail.com

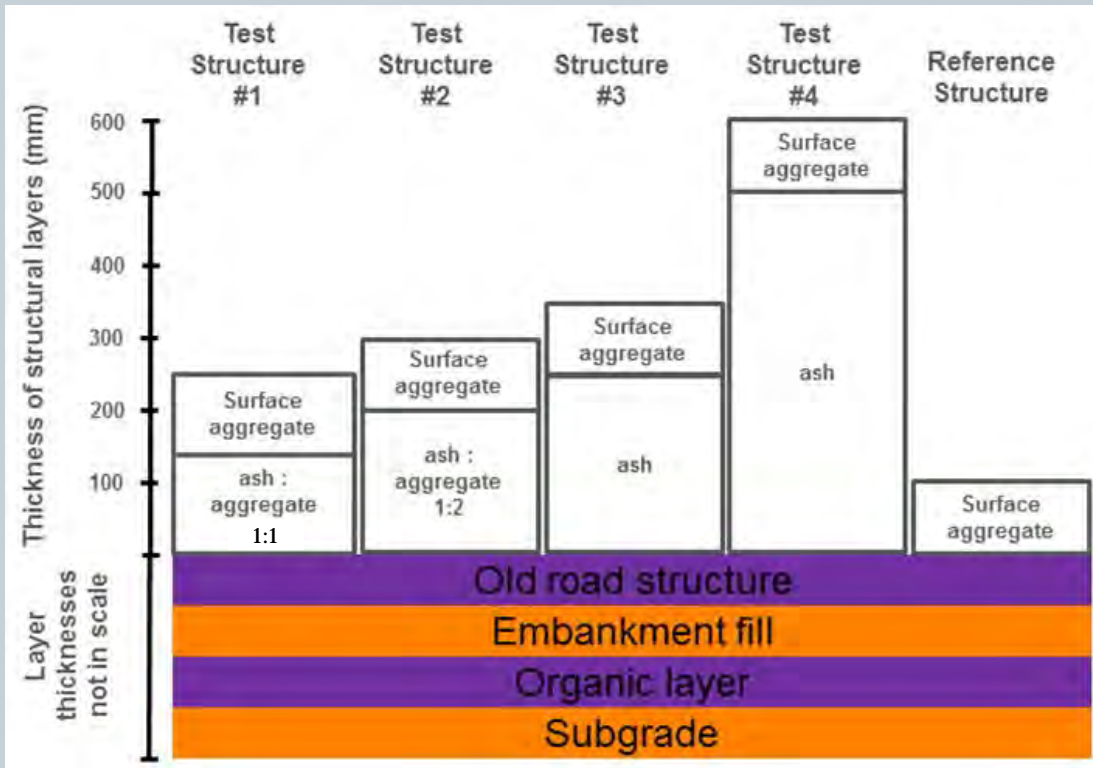
Road cross section

- Two uniform FA structure and two mixed FA / aggregate structure and reference structure
